Report of Geotechnical Investigation Dam Safety Assessment of Coal Combustion Surface Impoundments Minnesota Power Boswell Energy Center, Cohasset, MN

AMEC Project No. 3-2106-0174.0300

June 2010

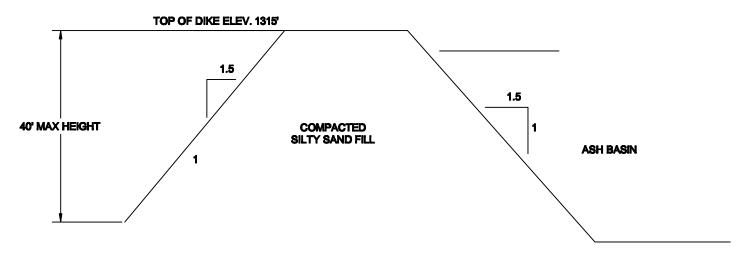
TYPICAL SECTION DIVIDING DIKE (WESTERN DIKE)

NOTE: SECTION IIIB OF EBASCO'S AUGUST 1981 REPORT STATED " DURING INITIAL FILLING OF THE BOTTOM ASH POND,
SOME INSTABILITY OF THE DIVIDING DIKE WAS NOTED AND A DOWNSTREAM BERM WAS CONSTRUCTED
TO INCREASE THE EFFECTIVE SLOPE, THEREBY INCREASING THE STABILITY OF THE EMBANKMENT. RIP-RAP WAS USED TO
INCREASE STABILITY OF THE UPSTREAM SLOPE". NO OTHER DETAILS OR DRAWINGS WERE PROVIDED REGARDING THIS MODIFICATION

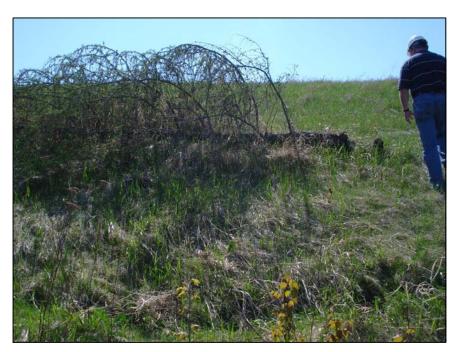
1-14
TREE WITHIN SOUTHERN EMBANKMENT DOWNSTREAM SLOPE

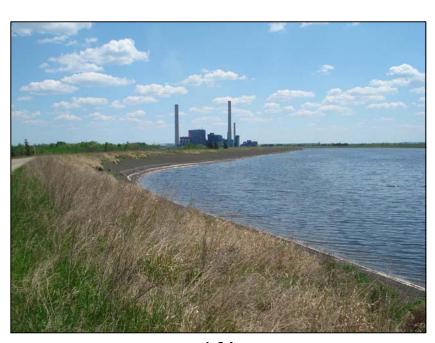
Erosion repair efforts were noted along the interior of the perimeters dikes (photos 1-34, 1-35, and 1-36). According to interoffice Minnesota Power emails, dike repairs were completed in May 2008 and June 2009. The affected areas include Pond 3, southeastern perimeter dike, Pond 4 northern, northeastern and eastern perimeter dike, and southwestern interior dike. The Bottom Ash Pond was in need of repair along the southern perimeter dike, and northeastern interior dike. Repair areas varied in size from 30 feet to 2100 feet in length, 4 feet to 45 feet in width, and 1 foot to 4 feet in depth. At the time of the inspection, wave action erosion was evident on the inside face of certain segments of the dikes.

1-34
VIEW FROM NORTHERN DIKE LOOKING TOWARDS BOSWELL ENERGY CENTER
ILLUSTRATES REPAIRED DIKE ALONG POND 4

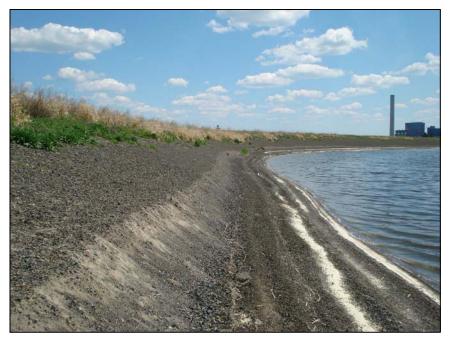
1-35
VIEW FROM NORTHERN UPSTREAM DIKE ALONG POND 4 LOOKING EAST - ILLUSTRATES PREVIOUS DIKE EROSION REPAIRS AND WAVE ACTION

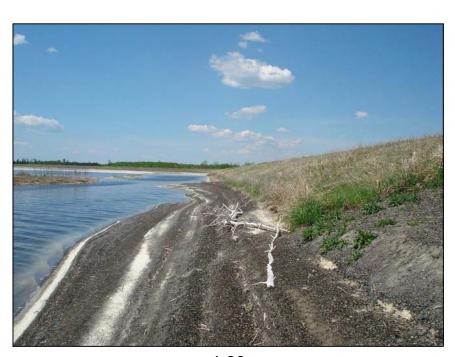
1-36
VIEW FROM NORTHERN UPSTREAM DIKE ALONG POND 4 LOOKING WEST - ILLUSTRATES PREVIOUS DIKE EROSION REPAIRS AND WAVE ACTION

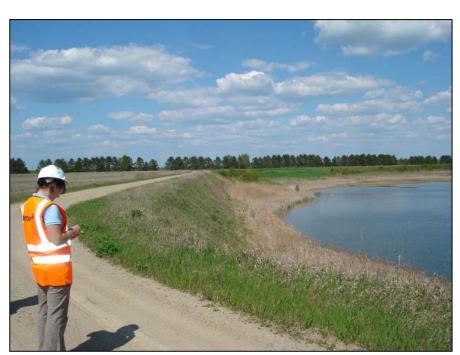
The Inactive Bottom Ash Pond has a 26.7-foot high, diked embankment. The pool had approximately 22 feet of freeboard at the time of the site visit (photo 3-14). Water within the structure was assumed to be runoff from recent rain events. The northeast and northwest portion of the ash in the pond is covered with grass (photos 3-1, 3-2, 3-3, 3-4, and 3-6). Steep interior dikes were noted along the northeast dike (photo 3-14). The dikes appeared to be maintained and mowed.

$\begin{tabular}{ll} \bf 3-14 \\ \hline \end{tabular}$ view from western dike looking northeast (note steep slopes)
